Pier Point Condominiums Association of Jacksonville Beach, Inc.

Jacksonville Beach, FL • August 18, 2022

FULL RESERVE STUDY

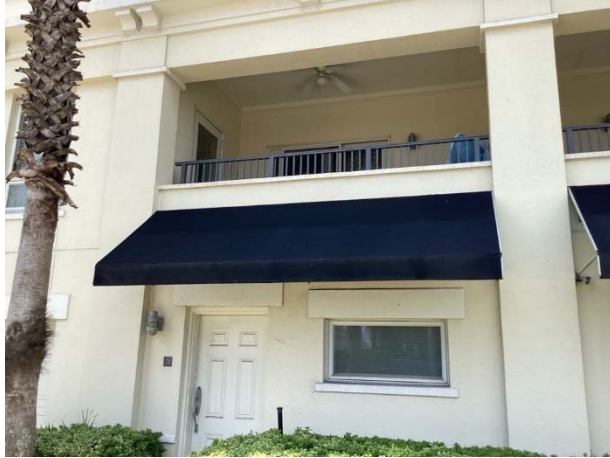
Condition: Fair overall with repairs evident. The Association is currently replacing the awnings and frames for \$12,000 and \$6,000 remains to be paid. We note downspouts discharging directly onto awnings, which will accelerate the deterioration of the awnings.

Awning at unit

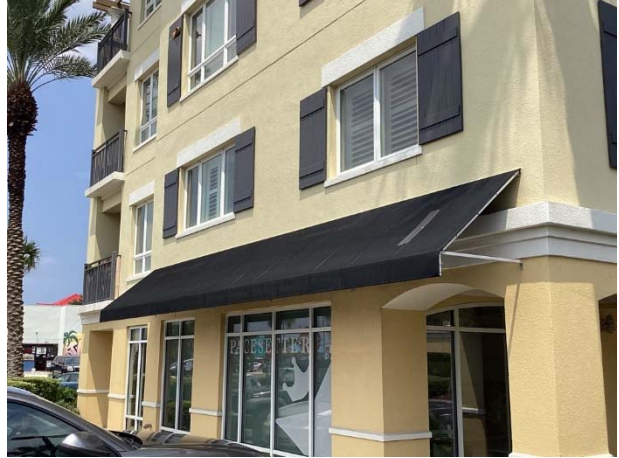
Awning with patch repair

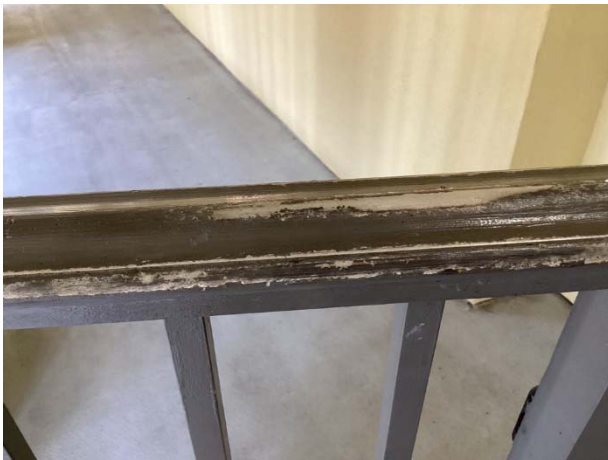
Conditions: The railings are in good to fair overall condition and the railing finishes are in good to fair condition with minor finish deterioration evident.

Finish deterioration at pool railing gate

Useful Life: Railings of this type have a useful life of up to 35 years with the benefit of periodic maintenance. Periodic maintenance should include applications of a protective paint finish and partial replacement of deteriorated aluminum every six- to eight-years.

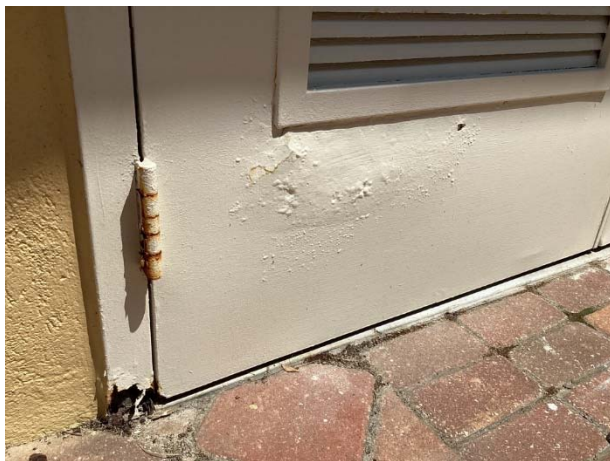
Condition: Varying condition from good to poor. We note corrosion at the pool storage room doors.

Corroded Doors at pool

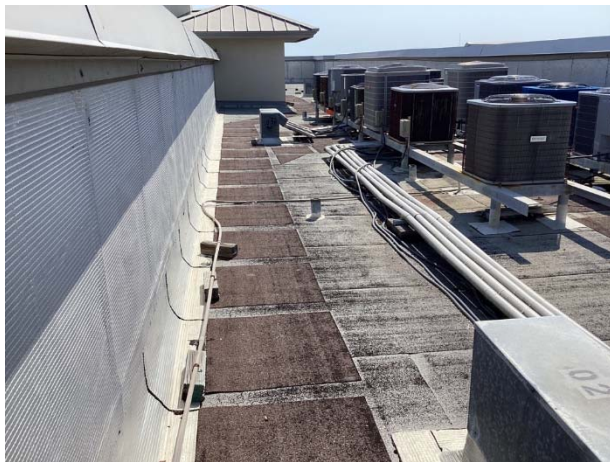
Condition: Fair overall with general deterioration, granule loss and standing water evident. Management does not report a history of leaks.

Modified bitumen roof overview

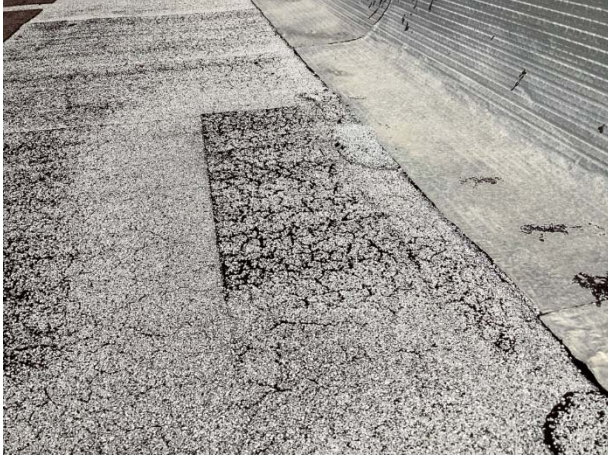
Deterioration evident

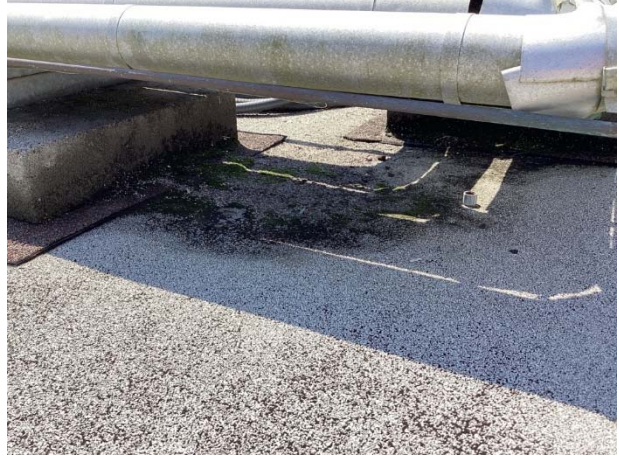
Stains beneath HVAC equipment

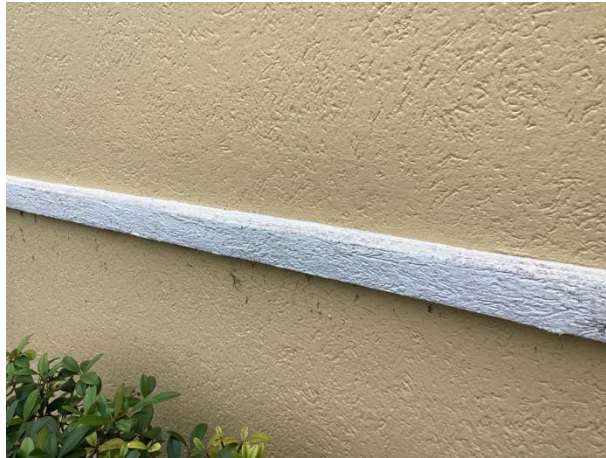
Isolated debris accumulation

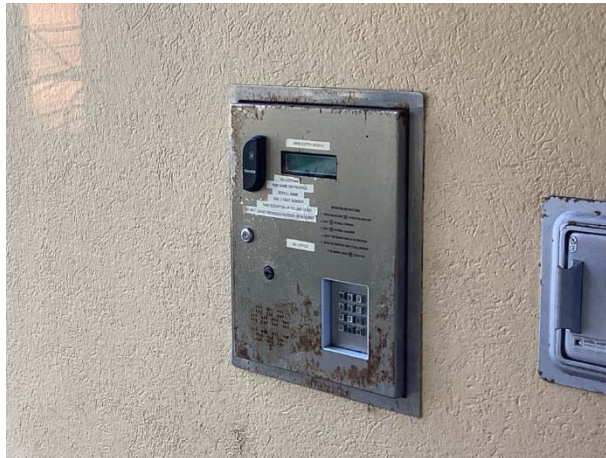
Condition: Reported unsatisfactory with operational deficiencies. We assume satisfactory condition upon replacement.

Deteriorated housing

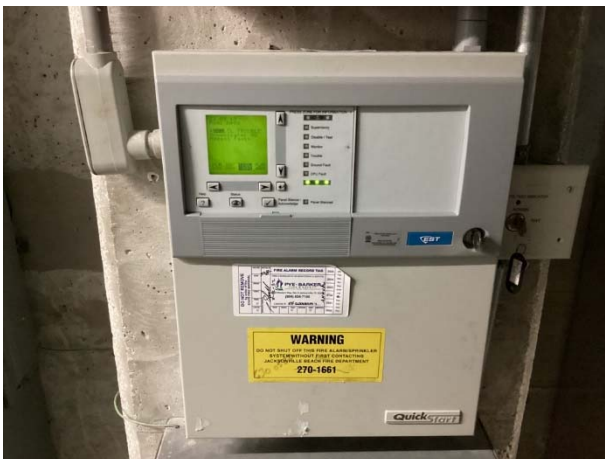
Control panel with trouble code

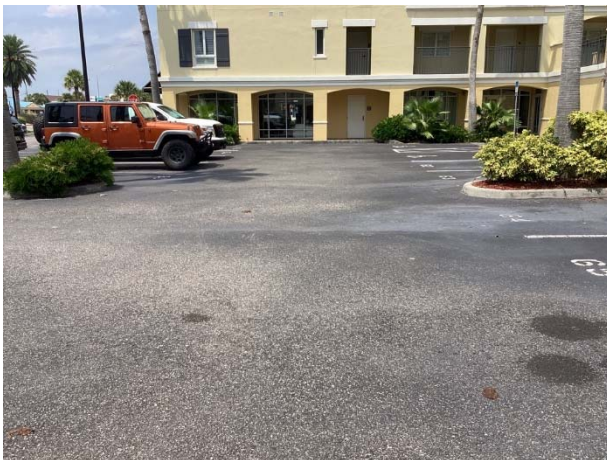
Condition: Good to fair overall with isolated areas of significant raveling and vehicular stains evident.

Asphalt pavement parking lot overview

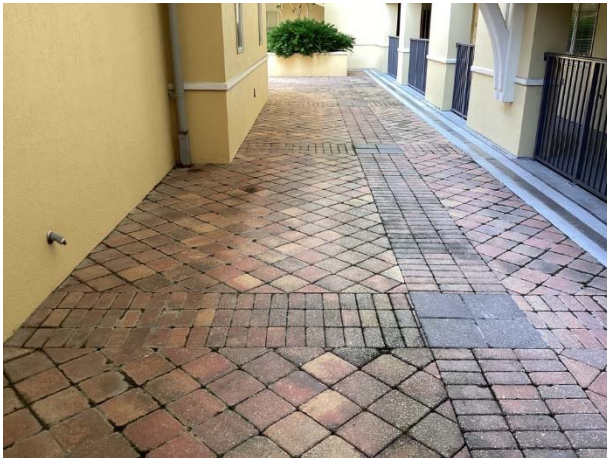
Condition: Reported unsatisfactory overall condition, requiring replacement. Management informs us that the replacement system will be of a different configuration of the current existing membrane and require inspections and capital repairs prior to a replacement at approximately 25-to 35-years.

Paver pool deck overview

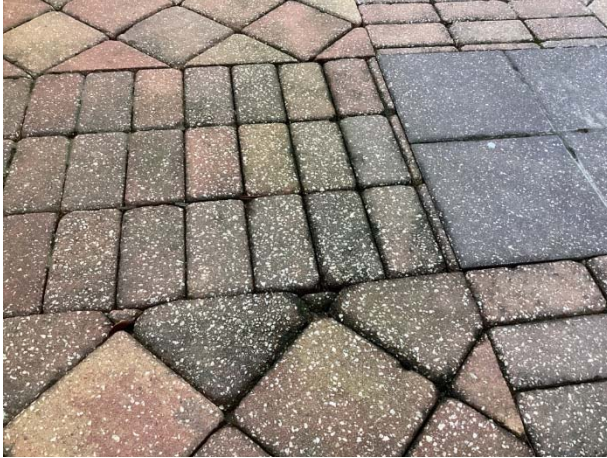
Spalled pavers

Useful Life: 25- to 35-years for the membrane with interim repairs every 15- to 20-years. The interim repairs will likely include:

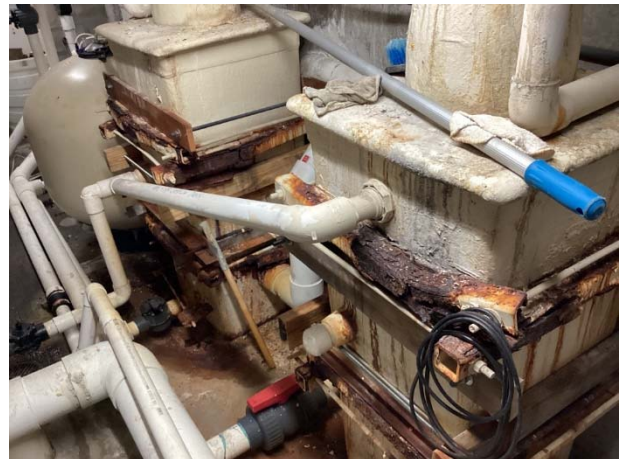
Condition: Reported satisfactory overall operating condition. We note significant corrosion at the filtration equipment braces

Significant corrosion at filtration equipment

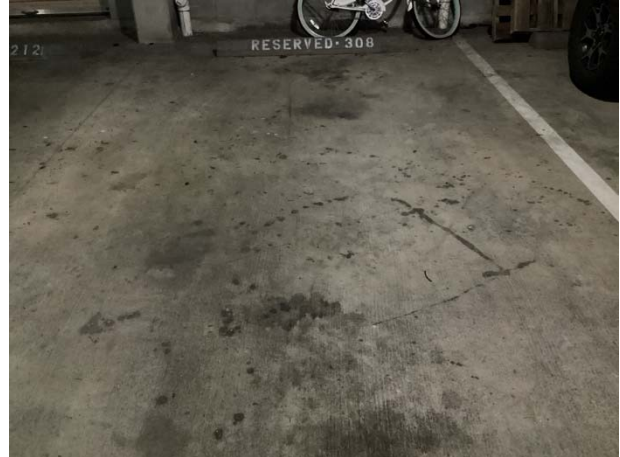
History and Condition: Good to fair overall with isolated stains. The concrete has never been repaired or partially replaced.

Vehicular stains

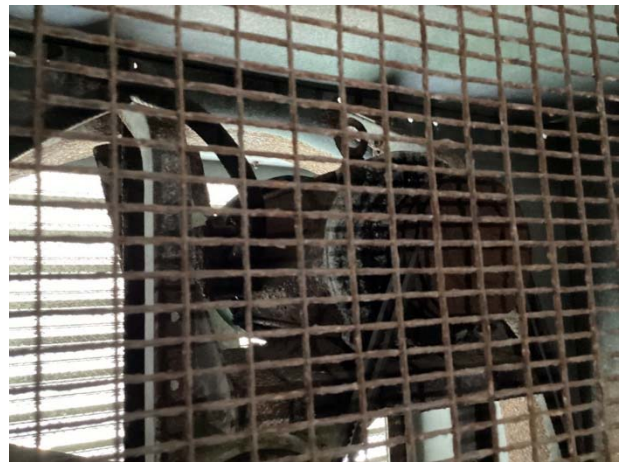
Rust at fan
