Pier Point Condominiums Association of Jacksonville Beach, Inc.

Jacksonville Beach, FL • August 18, 2022

FULL RESERVE STUDY

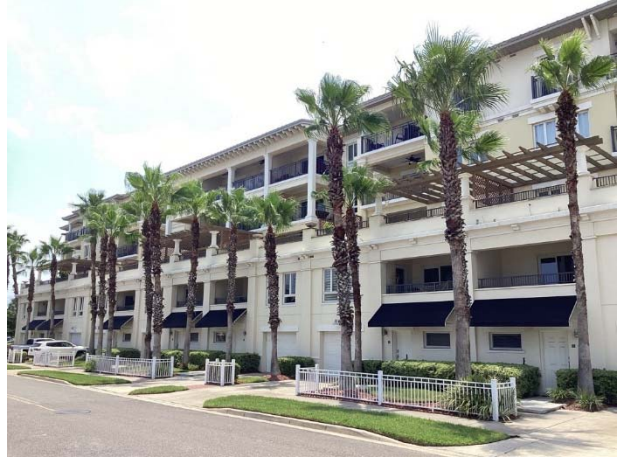
Condition: We not difficulty ascertaining the condition of the terrace style balconies due to lack of access. Management reports no issues or concerns with these areas at this time.

Terrace overview

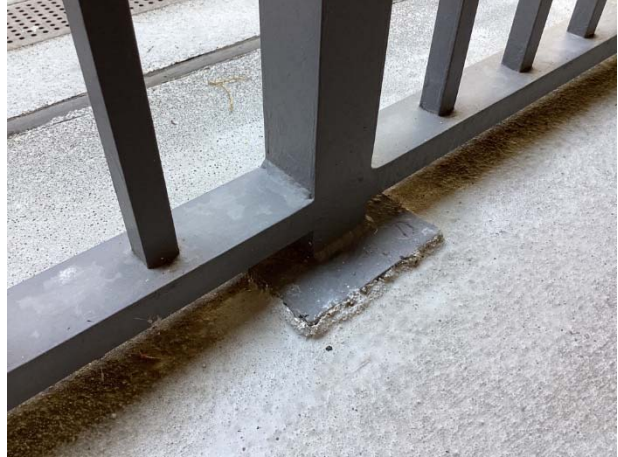
Mechanically attached railing post

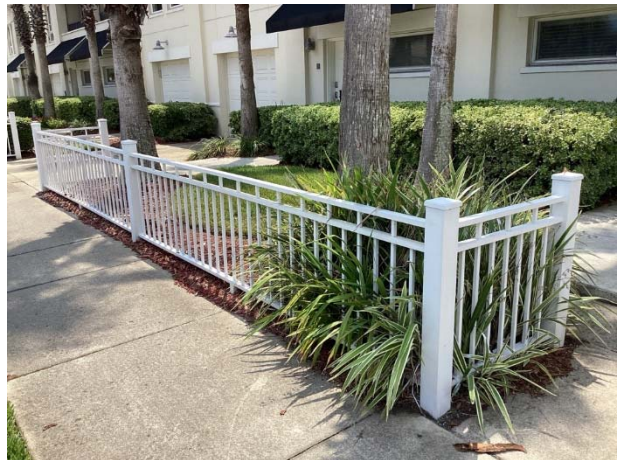
Aluminum railings at rear of building.

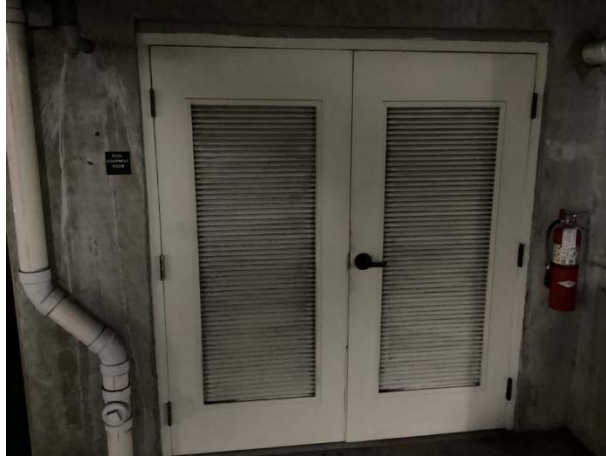
Pool mechanical equipment doors

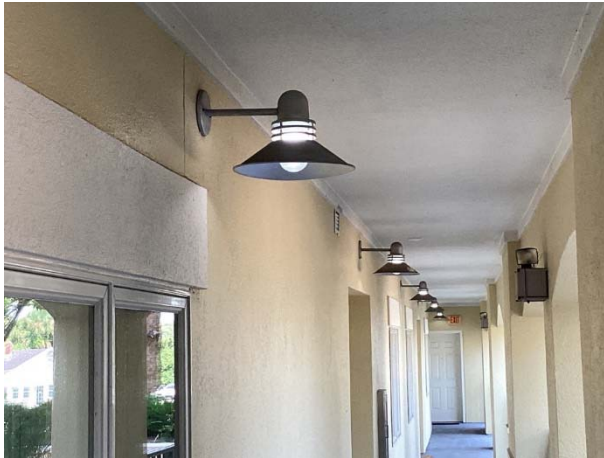
Condition: Good to fair overall, the Association reports a desire for replacement.

Exterior light fixtures

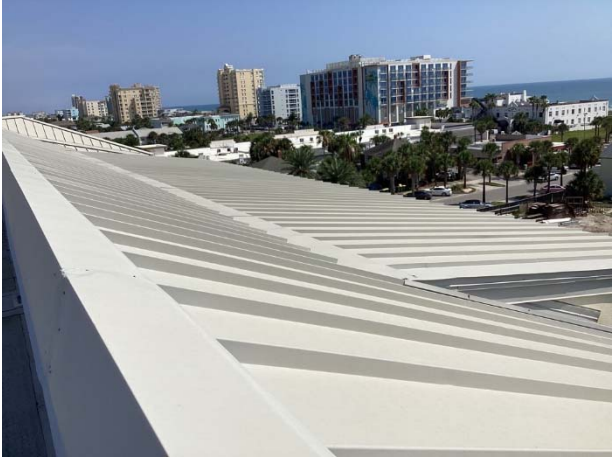
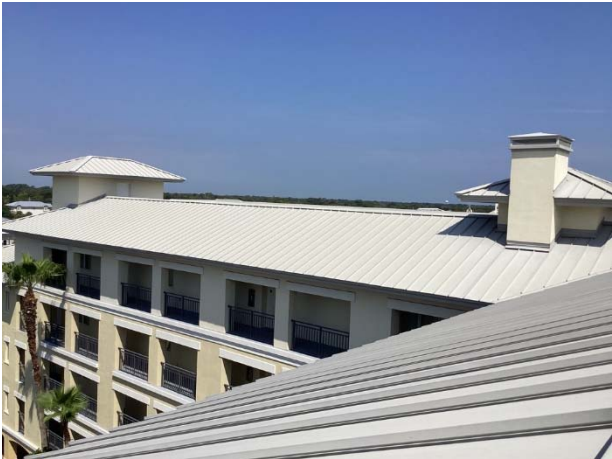
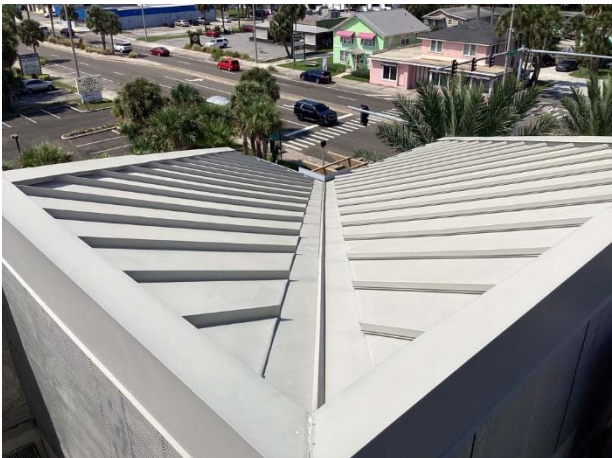
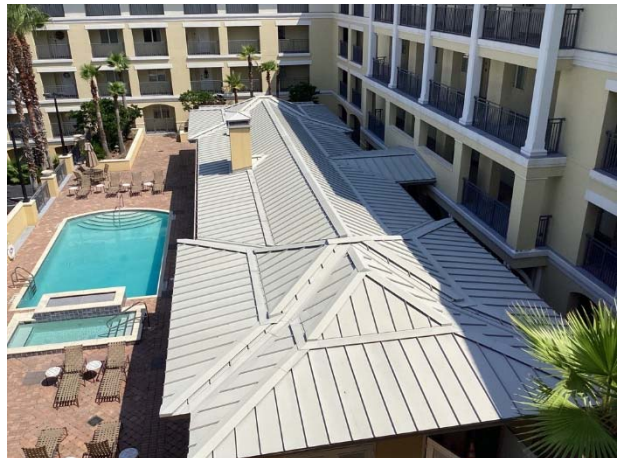
Condition: Good to fair overall with no significant deterioration evident from our visual inspection from the ground. Management does not report a history of leaks.

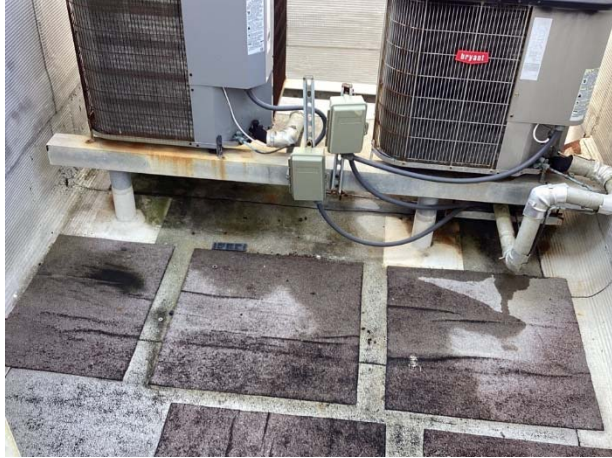
Standing water at lower roof

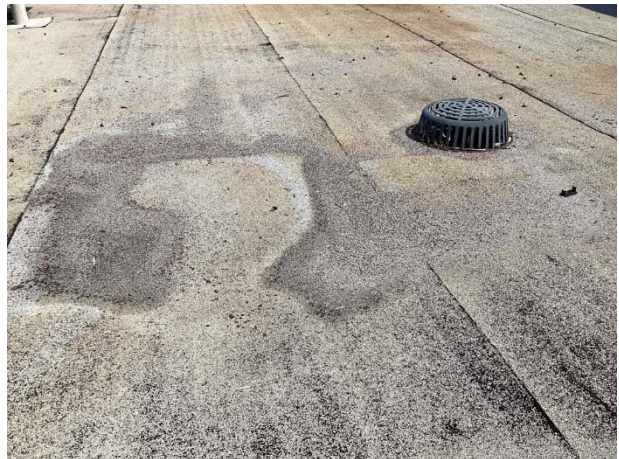
Granule accumulation at low spots

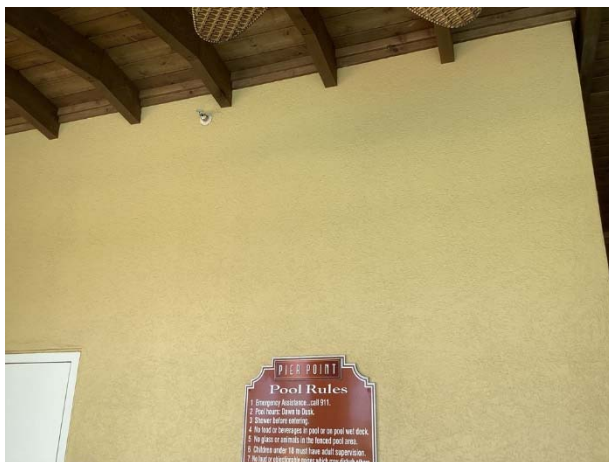
Condition: Good overall with no significant deterioration evident.

Stucco at pool rest room exterior

Useful Life: We recommend inspections, repairs and paint finish applications every five- to seven-years.

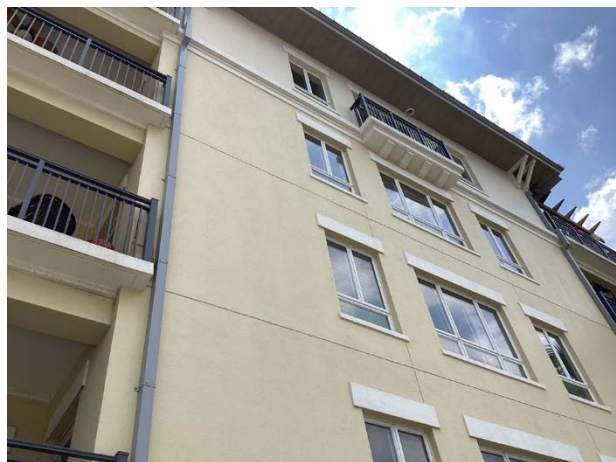
Stucco wall finishes

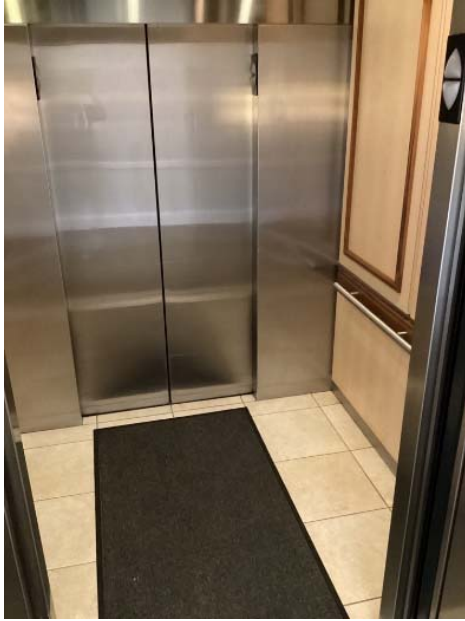
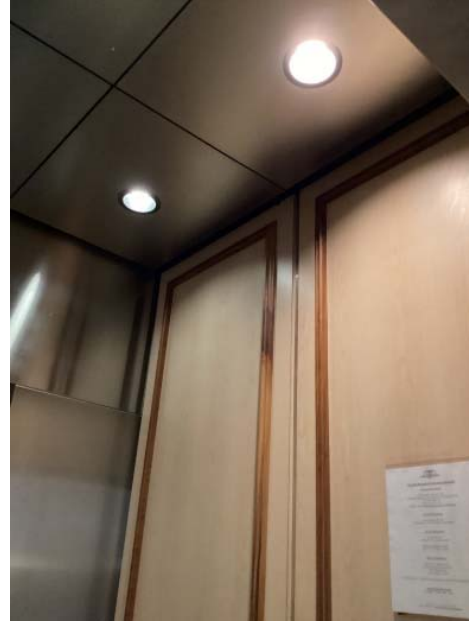
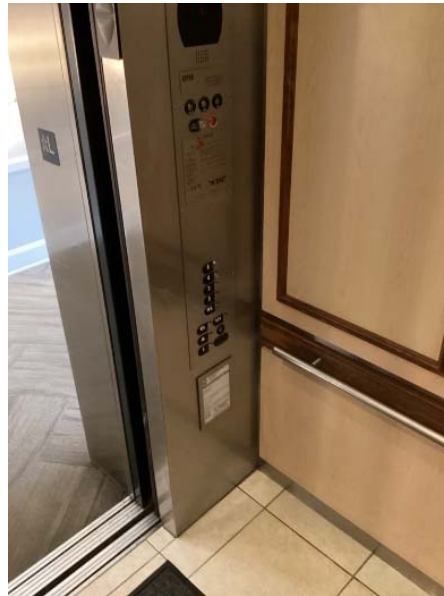
Condition: Good overall with no significant deterioration evident.

Elevator cab finishes

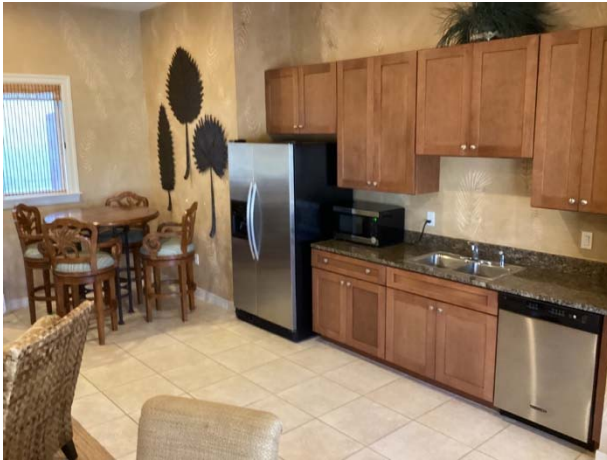
Condition: Good to fair overall

Club room overview

Expenditure Detail Notes: Expenditure timing and costs are depicted in the **Reserve Expenditures** table in Section 3. The complete renovation should include replacement of all components listed above and the partial renovations should include the following:

- Application of paint finishes and wall coverings
- Replacement of up to fifty percent (50%) of the furnishings
- Replacement of the rest room fixtures
- Replacement of the rest room tile floors

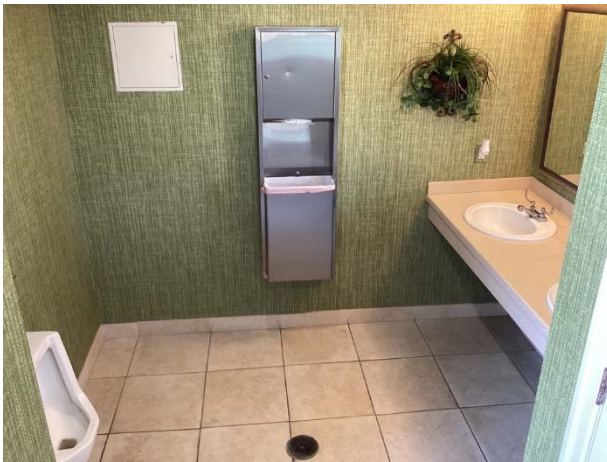
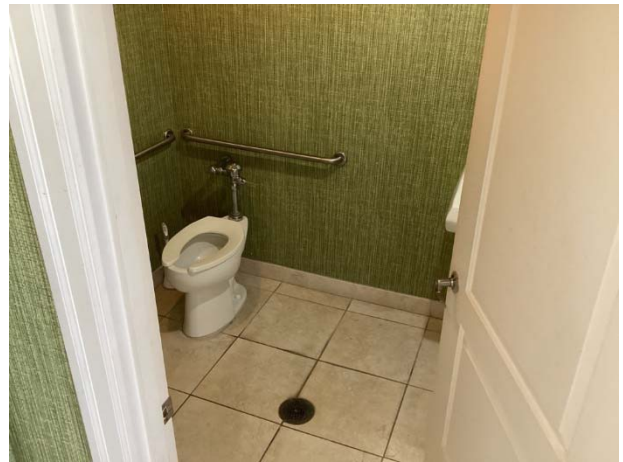
Rest room overview

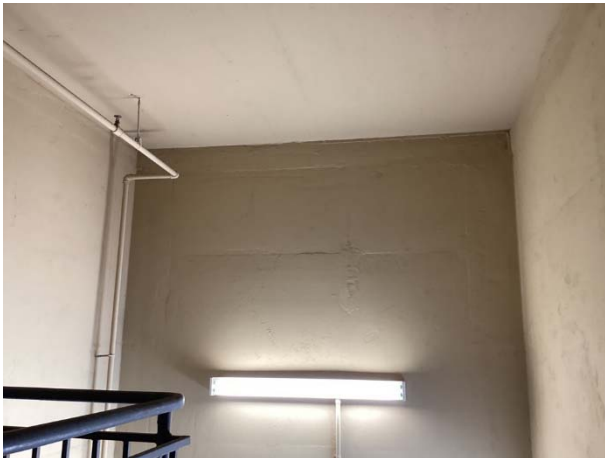
Conditions: Fair overall

Stairwell paint finishes

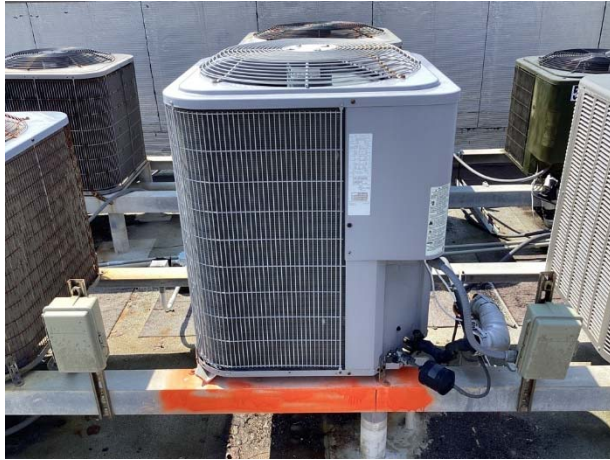
Condition: Reported satisfactory without operational deficiencies

Lobby condensing unit

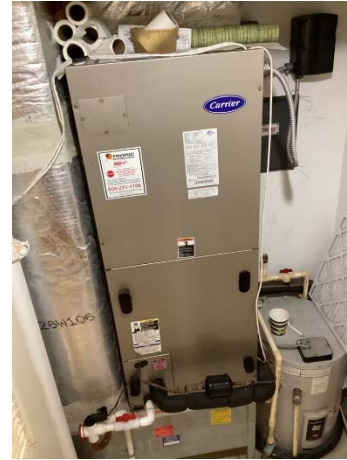
Split system air handling unit at pool rest room

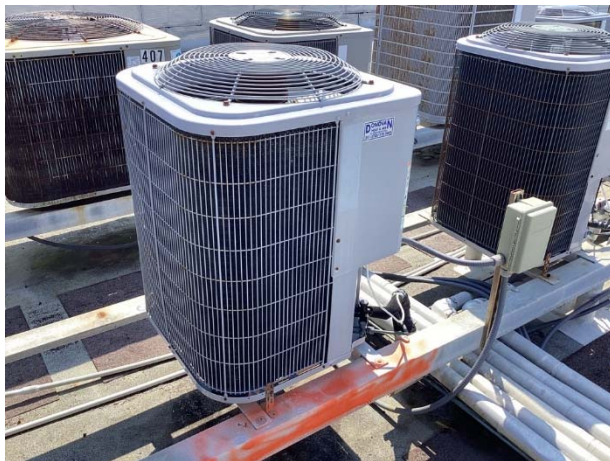
Split system condensing unit to club room

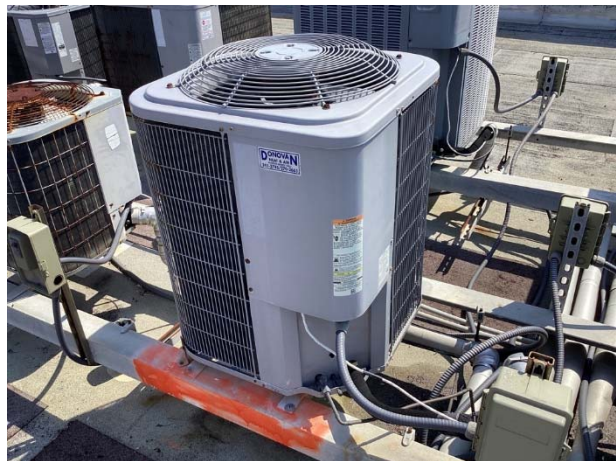
Fitness room condensing unit

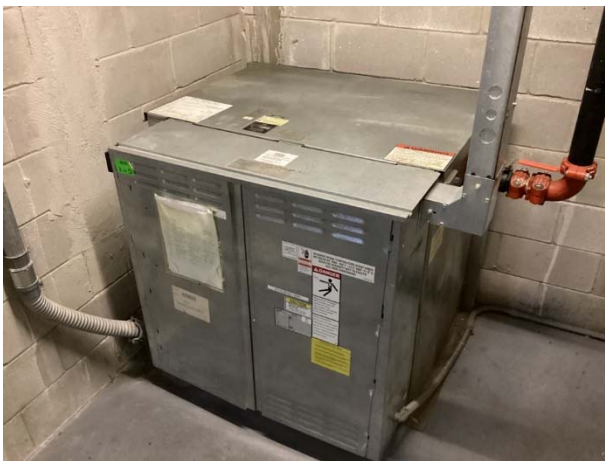
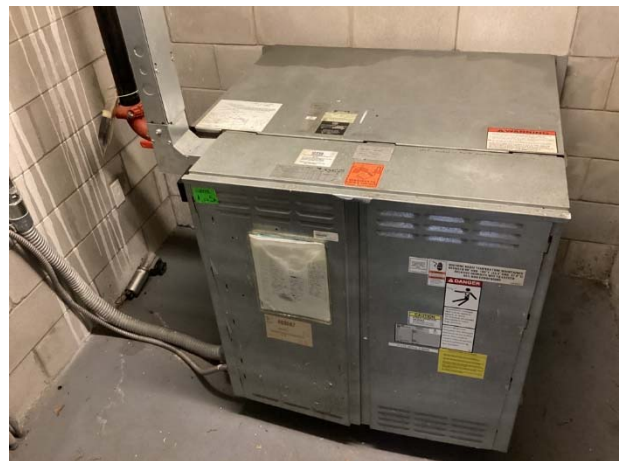
Condition: Reported satisfactory and service interruptions are reportedly infrequent

Hydraulic elevator equipment

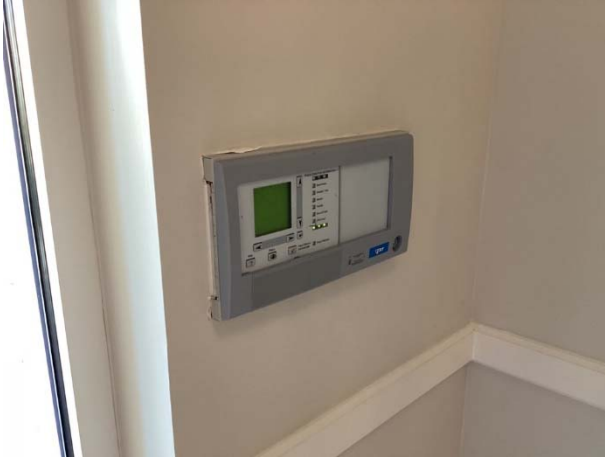
Conditions: Reported satisfactory without operational deficiencies

Lobby secondary panel

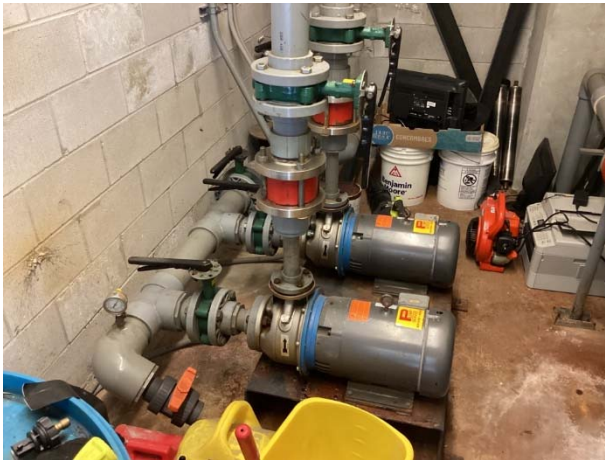
Condition: Reported satisfactory without operational deficiencies.

Domestic water pumps

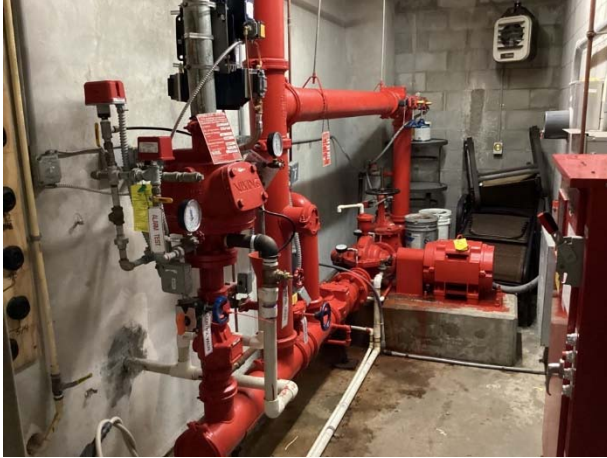
Condition: Reported satisfactory without operational deficiencies

Fire suppression pump

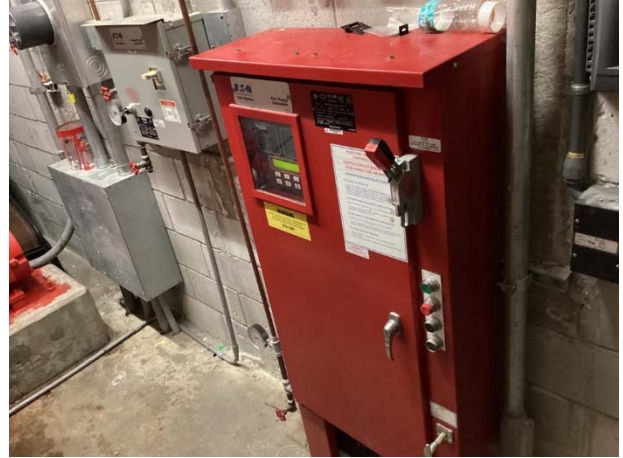
Fire suppression pump controls

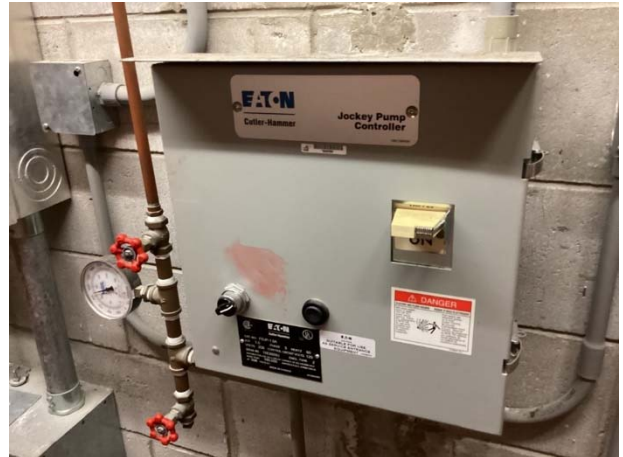
Jockey pump controls

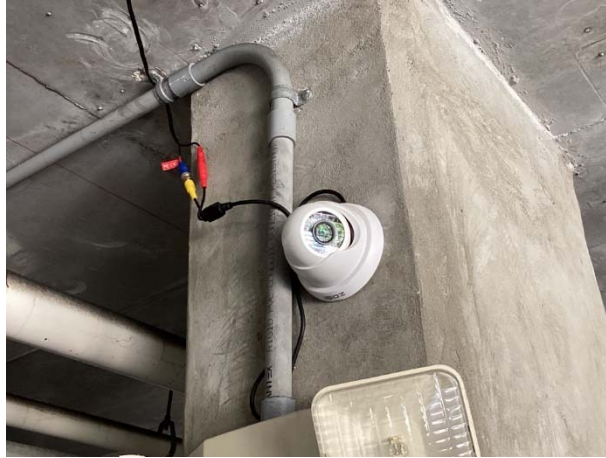
Condition: Reported satisfactory without operational deficiencies

Security system camera

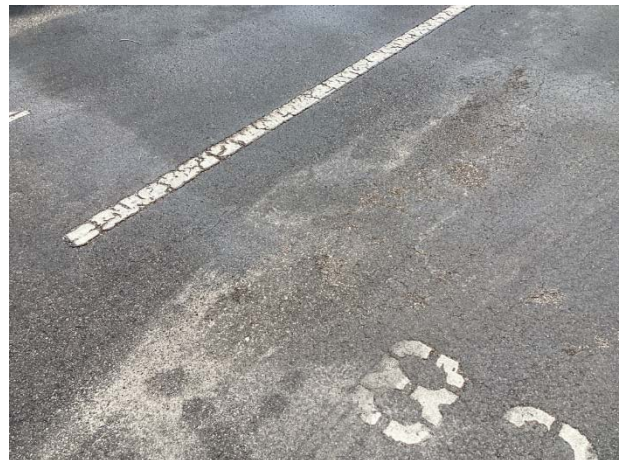
Area of significant raveling

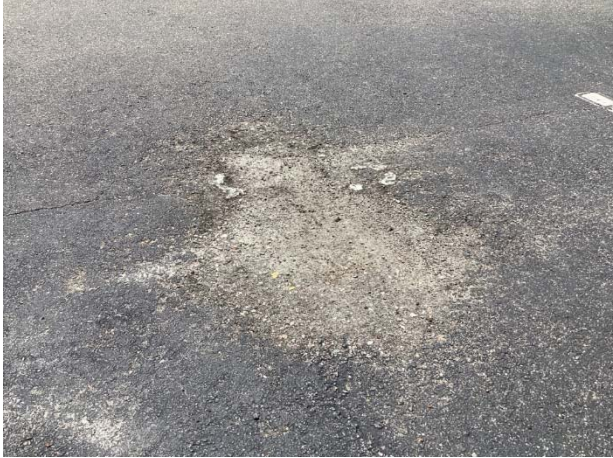
Area of significant raveling

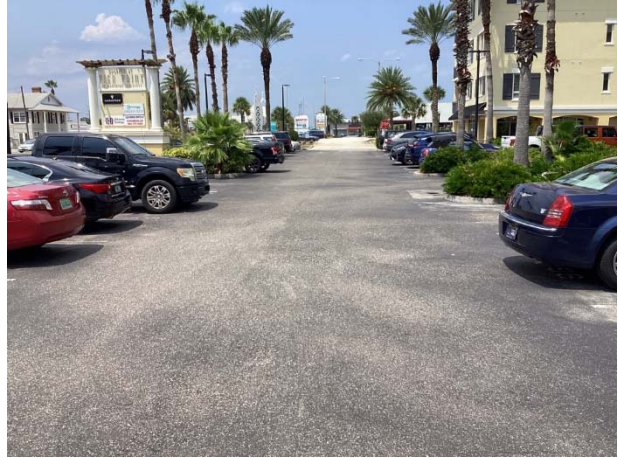
Asphalt pavement parking lot overview

The manner of repaving is either a mill and overlay or total replacement. A mill and overlay is a method of repaving where cracked, worn and failed pavement is mechanically removed or milled until sound pavement is found. A new layer of asphalt is overlaid atop the remaining base course of pavement. Total replacement includes

the removal of all existing asphalt down to the base course of aggregate and native soil followed by the application of two or more new lifts of asphalt. We recommend mill and overlayment on asphalt pavement that exhibits normal deterioration and wear. We recommend total replacement of asphalt pavement that exhibits severe deterioration, inadequate drainage, pavement that has been overlaid multiple times in the past or where the configuration makes overlayment not possible. Based on the apparent visual condition and configuration of the asphalt pavement, we recommend the mill and overlay method of repaving at Pier Point Condominiums.

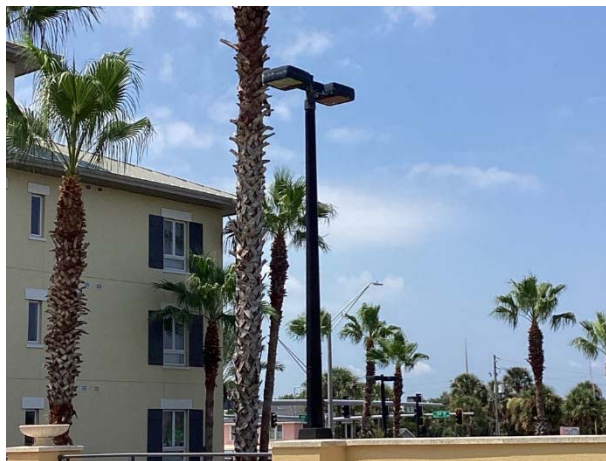
Condition: Good to fair overall

Light pole and fixtures

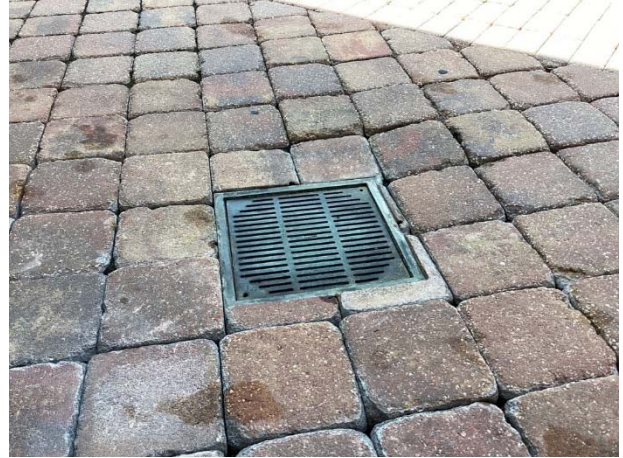
Pavers deck drain

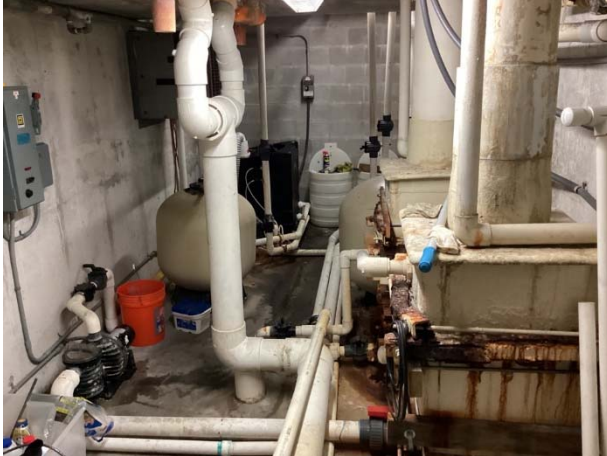
Condition: Reported satisfactory overall operating condition. We note significant corrosion at the filtration equipment braces

Pool mechanical equipment room

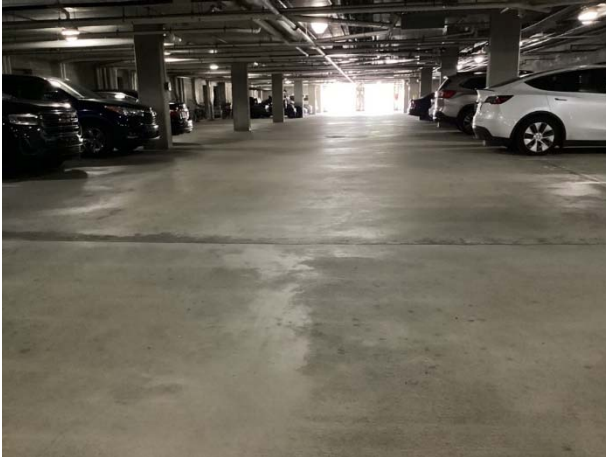
History and Condition: Good to fair overall with isolated stains. The concrete has never been repaired or partially replaced.

On-grade garage floor overview

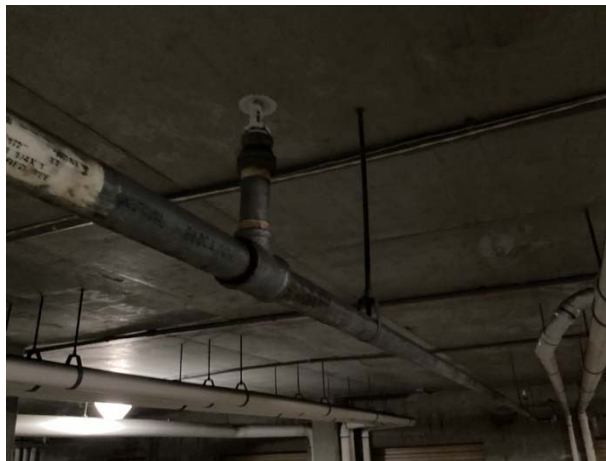
Condition: Good to fair overall

Fire suppression system
