Pier Point Condominiums Association of Jacksonville Beach, Inc.

Jacksonville Beach, FL • August 18, 2022

FULL RESERVE STUDY

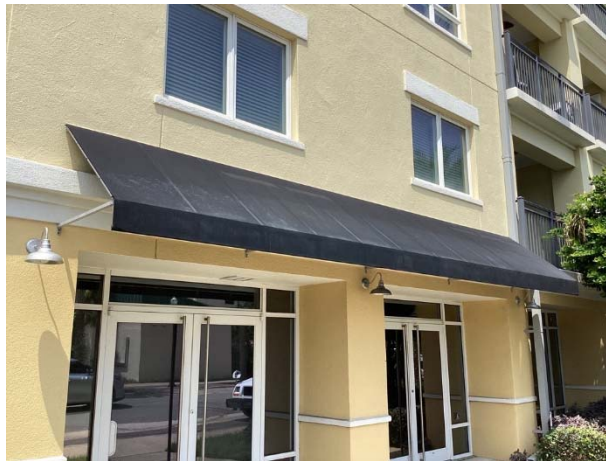
Awning

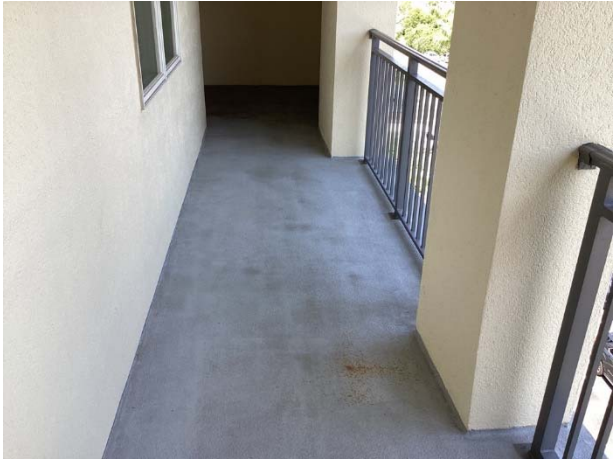
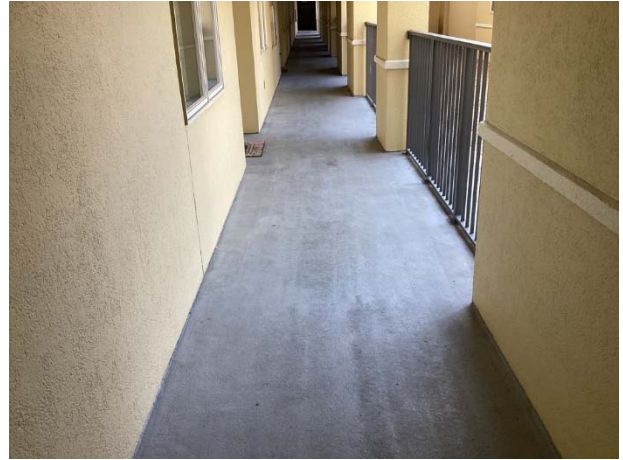
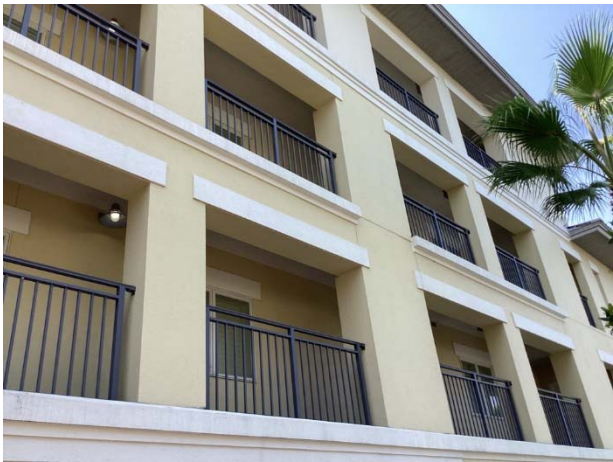
Condition: Good overall with no significant deterioration evident.

Breezeway overview

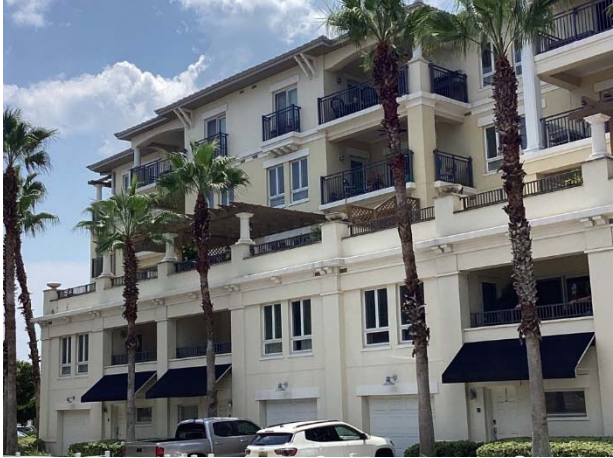
Condition: We not difficulty ascertaining the condition of the terrace style balconies due to lack of access. Management reports no issues or concerns with these areas at this time.

Terrace overview

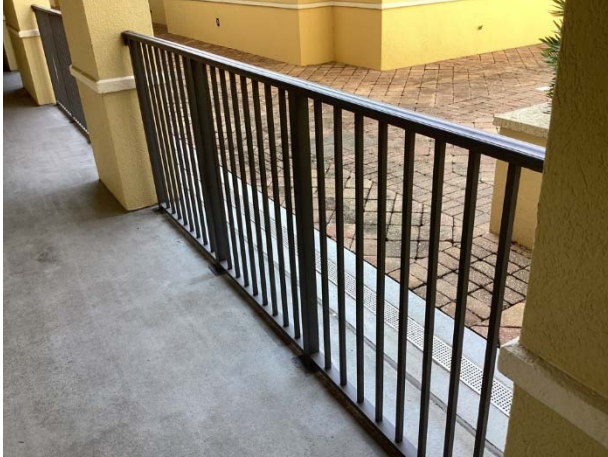
Conditions: The railings are in good to fair overall condition and the railing finishes are in good to fair condition with minor finish deterioration evident.

Aluminum railings

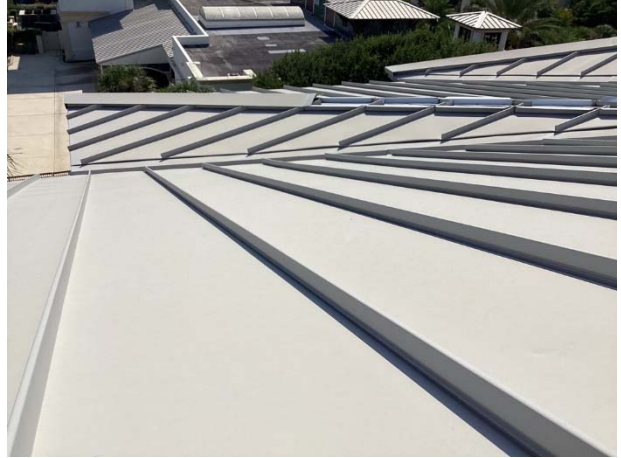
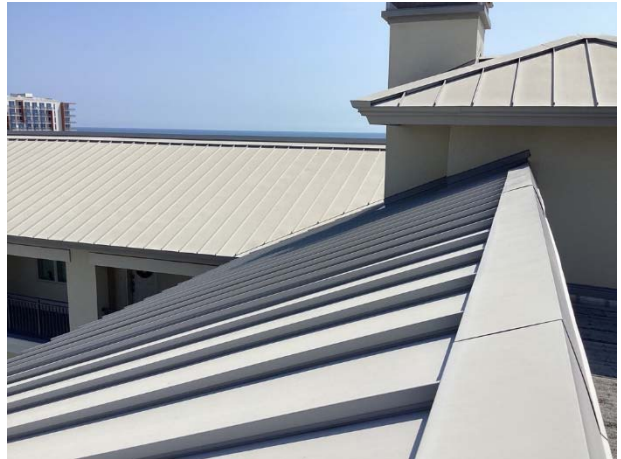
Condition: Good to fair overall with no significant deterioration evident from our visual inspection from the ground. Management does not report a history of leaks.

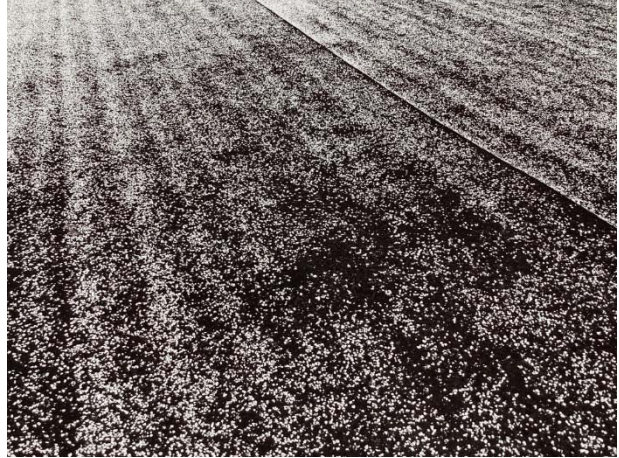
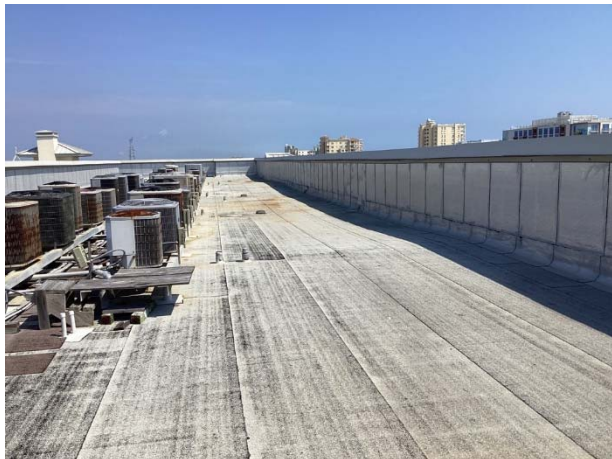
Granular loss

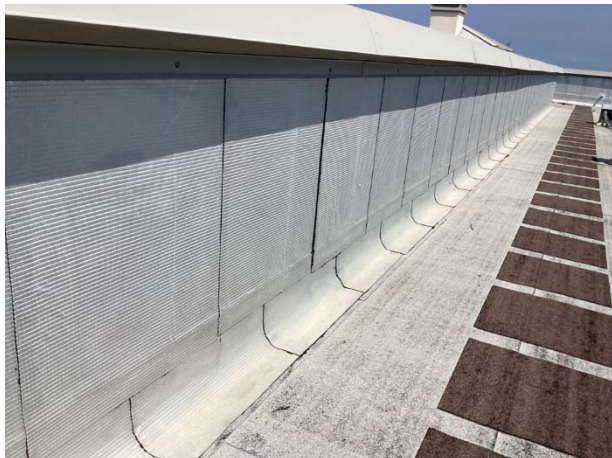
Flashing

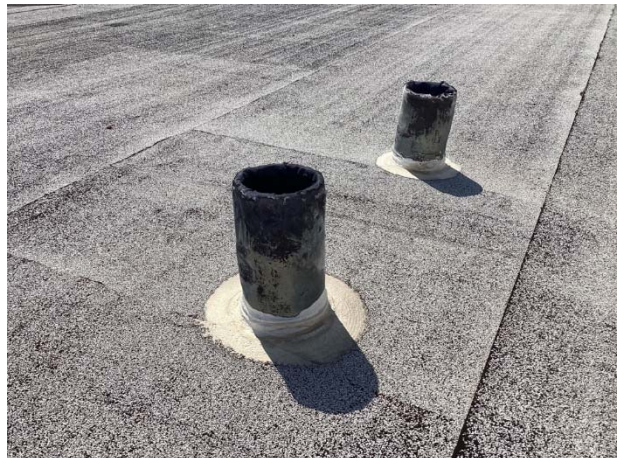
Vent pipes

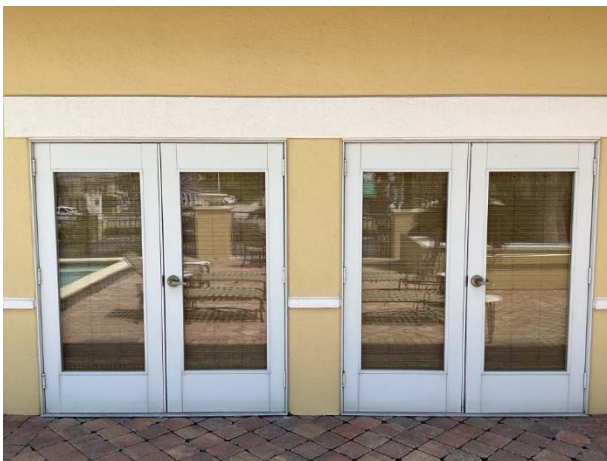
Condition: Good to fair overall with no significant deterioration evident.

Club room doors

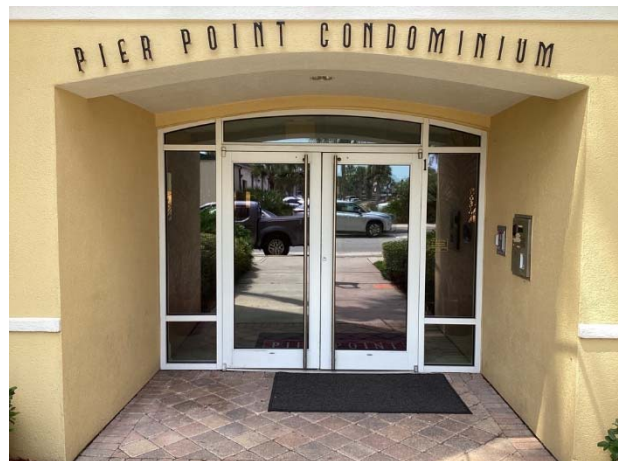
Lobby entrance doors

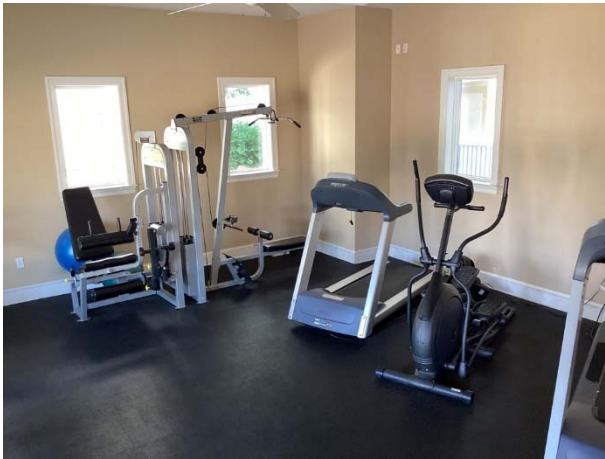
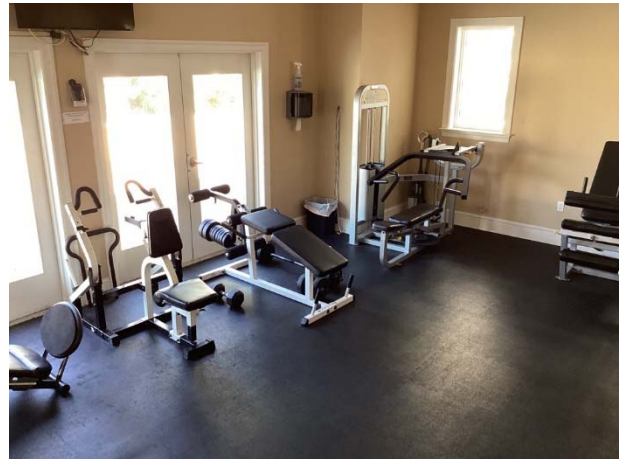
Conditions: Good to fair overall with no significant deterioration evident.

Exercise room

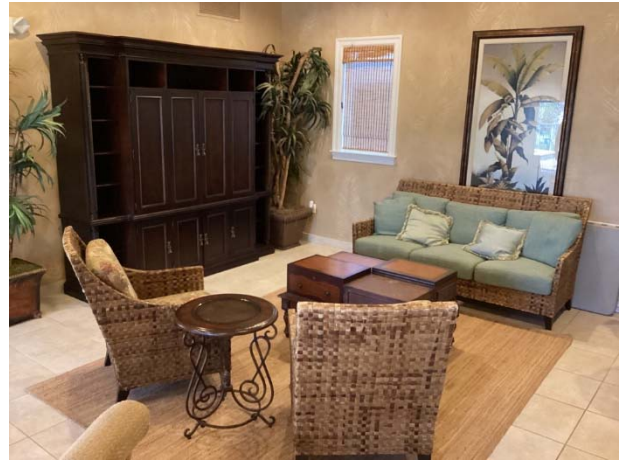
Condition: Good to fair overall

Club room overview

Expenditure Detail Notes: Expenditure timing and costs are depicted in the **Reserve Expenditures** table in Section 3. The complete renovation should include replacement of all components listed above and the partial renovations should include the following:

- Application of paint finishes and wall coverings
- Replacement of up to fifty percent (50%) of the furnishings
- Replacement of the rest room fixtures
- Replacement of the rest room tile floors

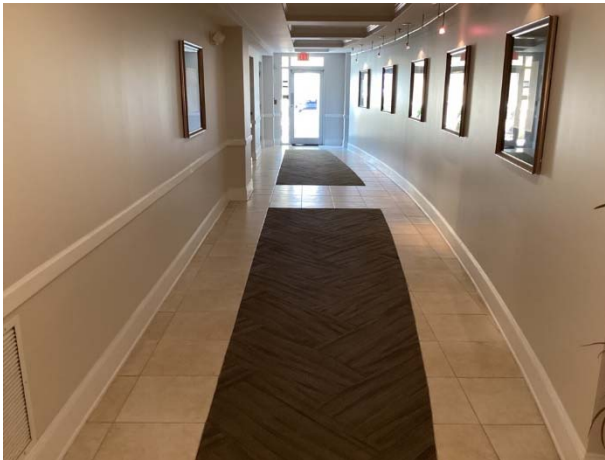
Condition: Good overall with no significant deterioration evident.

Carpet and tile overview

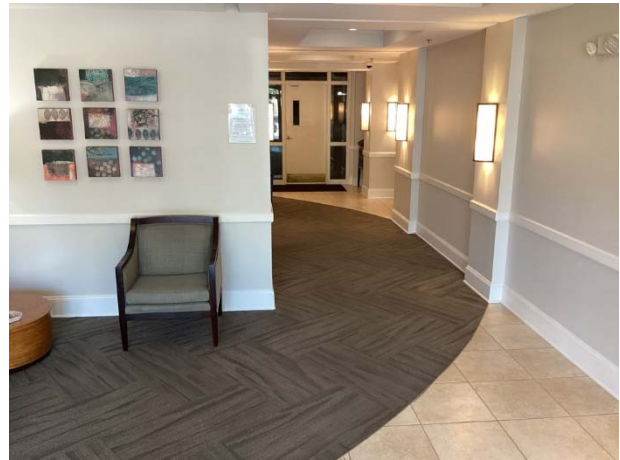
Carpet overview

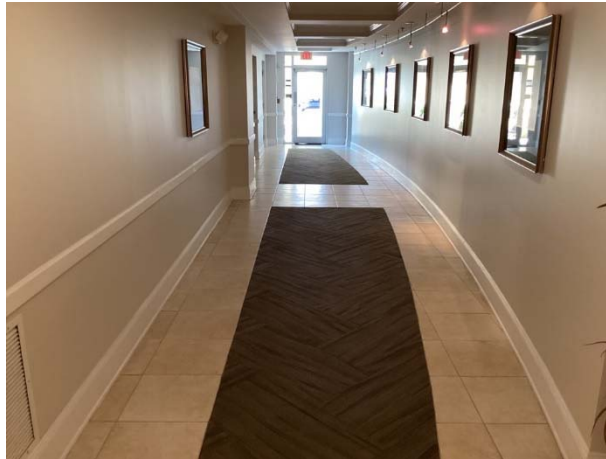
Condition: Good overall with no significant deterioration evident.

Carpet and tile overview

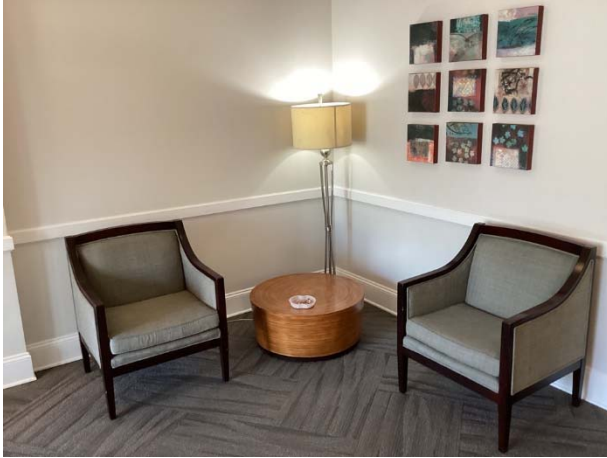
Condition: Good overall

Lobby furnishings

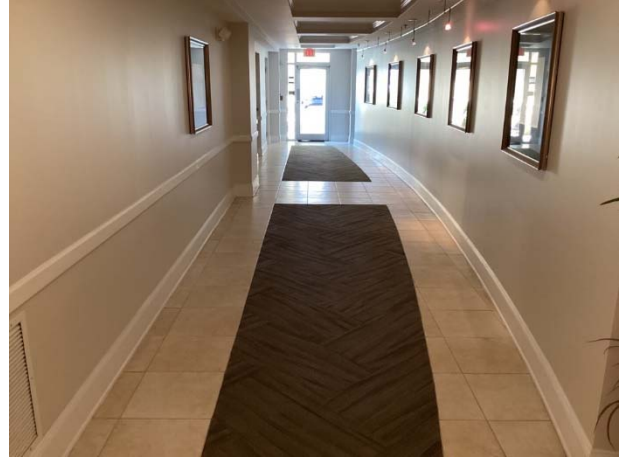
Lobby overview

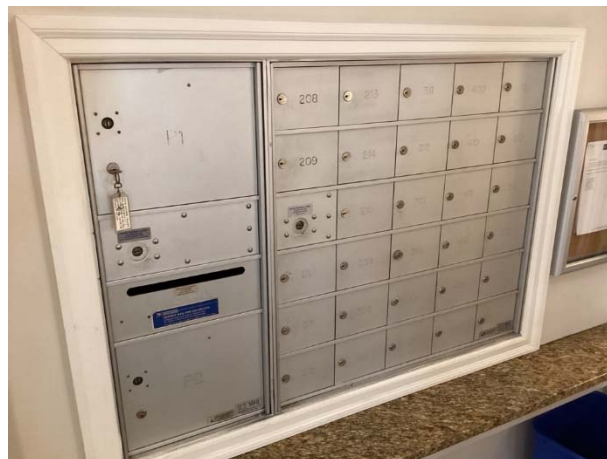
Condition: The mailboxes are in good to fair overall condition.

Mailbox station

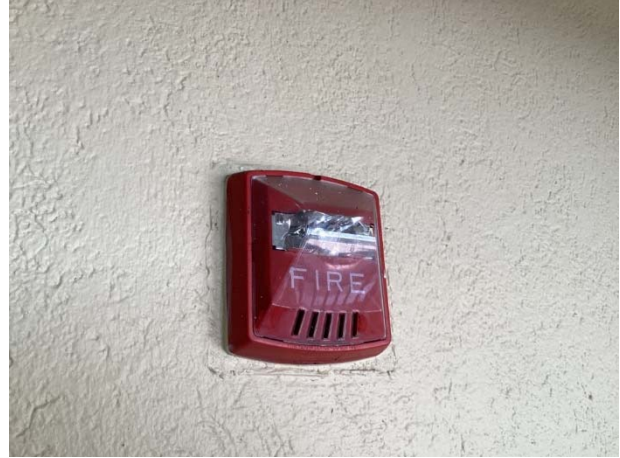
Conditions: Reported satisfactory without operational deficiencies

Audiovisual device

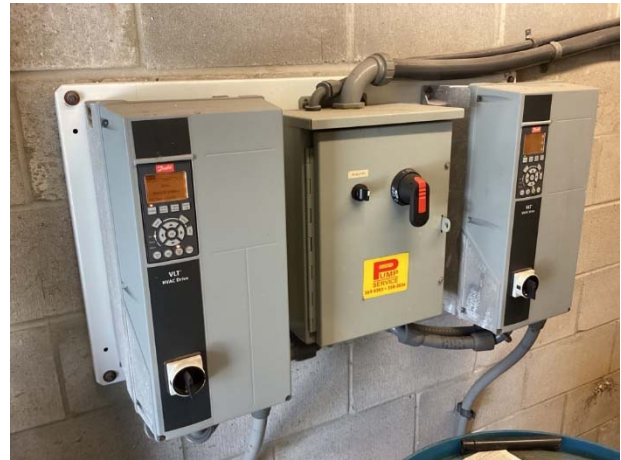
Condition: Reported satisfactory without operational deficiencies.

Variable frequency drives

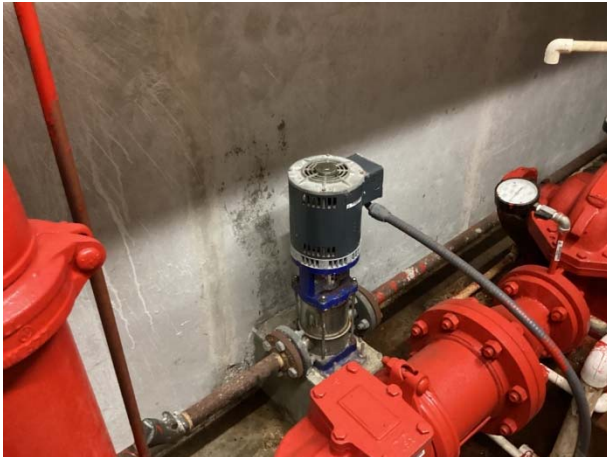
Condition: Reported satisfactory without operational deficiencies

Jockey pump

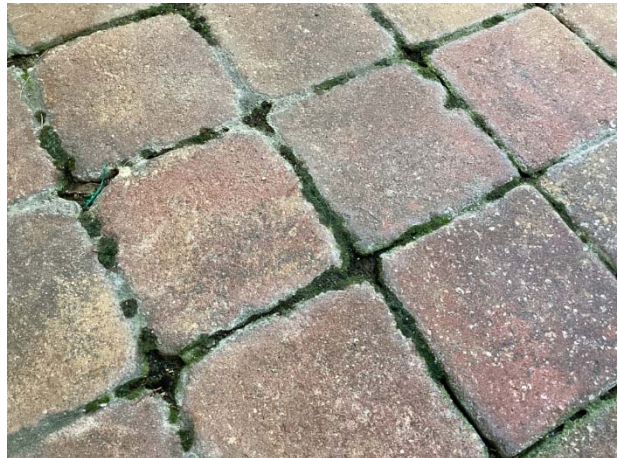
Organic growth between pavers evident

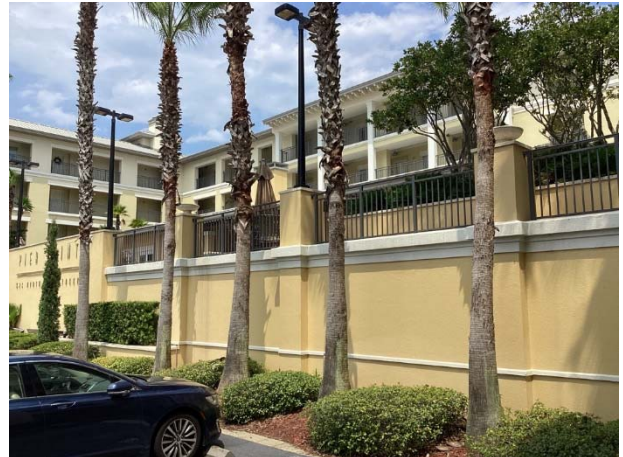
Condition: Reported unsatisfactory overall condition, requiring replacement. Management informs us that the replacement system will be of a different configuration of the current existing membrane and require inspections and capital repairs prior to a replacement at approximately 25-to 35-years.

Elevated pool deck viewed from parking lot

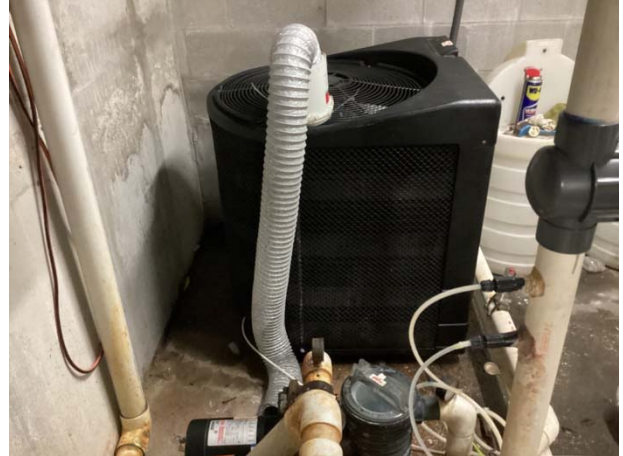
Pool heater

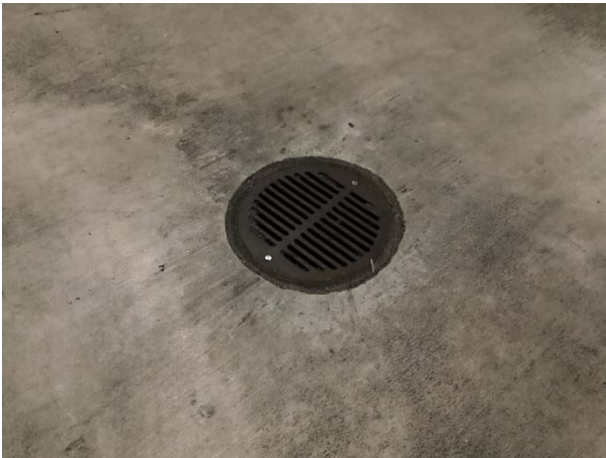
Drain cover

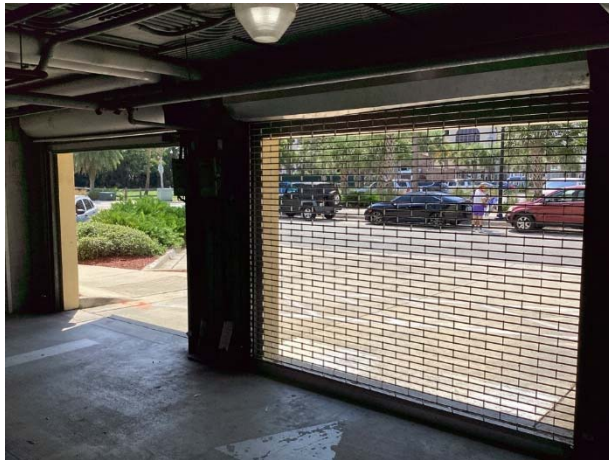
Condition: Good to fair overall with no visible deterioration evident

Garage door

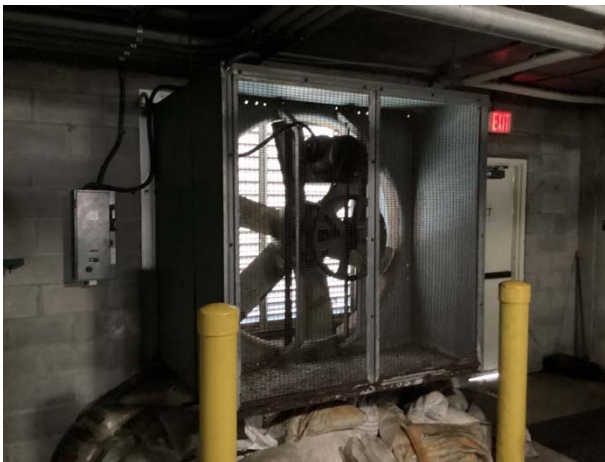
Condition: Reported satisfactory without operational deficiencies

Exhaust fan
